Matrima

November 2014

Laying compacted clay slabs on a geotextile under layer in one of the six mini test ponds at Matrimandir

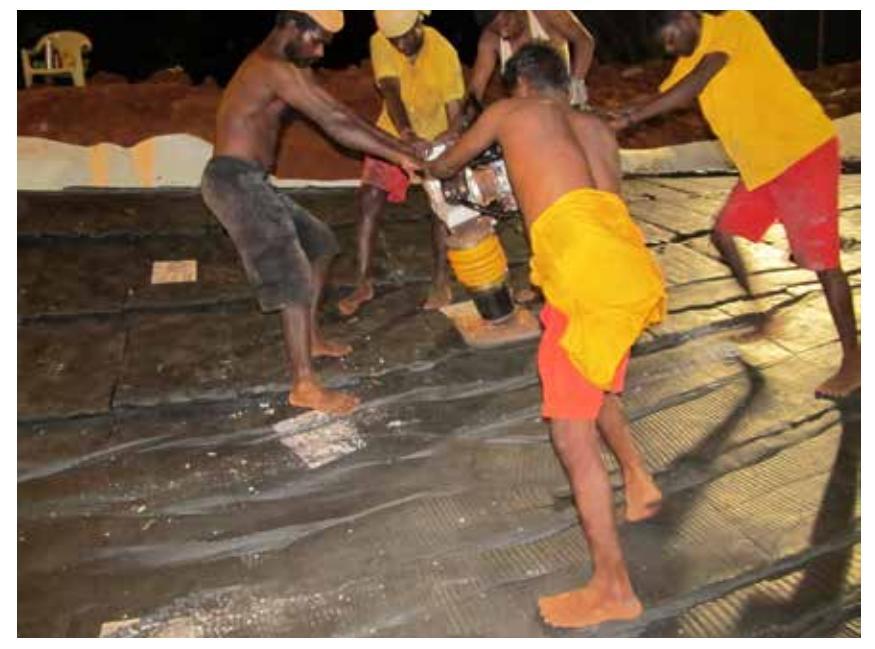
A "pogo stick" jumper is used to knead the clay slabs so they join and become one waterproof layer.

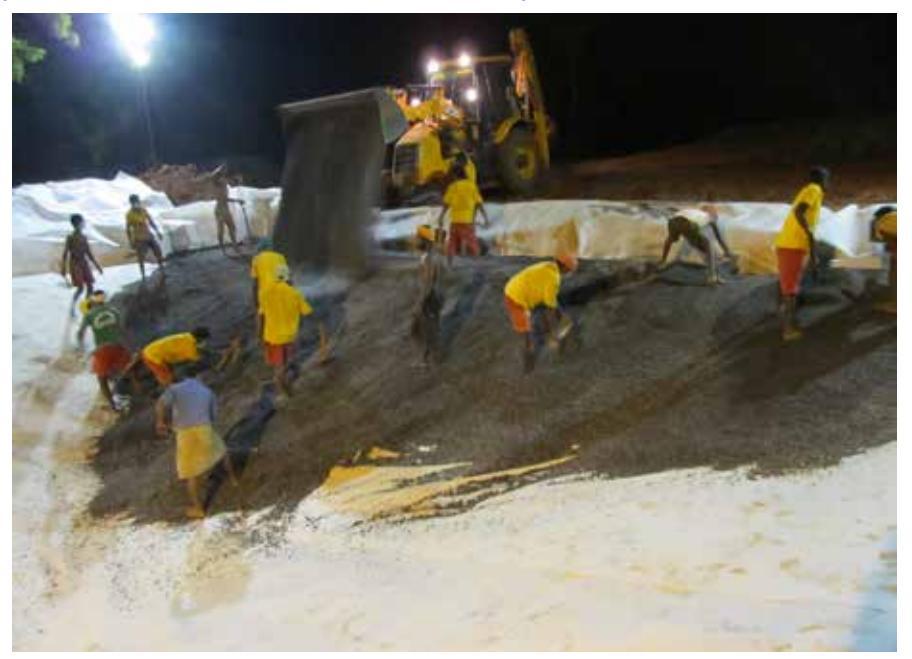
The sealed clay layer was covered with a protective layer of white geotextile, and then with a thick layer of granite chips.

The work at the pond proceeded through two more phases,- first the whole clay layer was covered by a thin layer of geotextile,- a polyester fabric laid on it to protect the clay from abrasion from above.

Then, as a final layer, the whole of this area was covered by a thick layer of granite stone chips. This last layer was deemed to be necessary because we had observed, in the floors of local clay ponds in the Auroville area. that this soft layer was prone to being pierced by an unexpected pest: crabs! Simple land crabs, seeking protection from the heat of the sun as the ponds dried out in summer, were found to burrow straight down through the clay leaving a neat round hole about 5 centimeters wide right through the clay layer. If this were to happen in our test pond (for the crabs would move into it one day for sure) then right away the pond would leak and all the

work would be spoiled. So, a tthick layer of granite chips would keep these pests away!

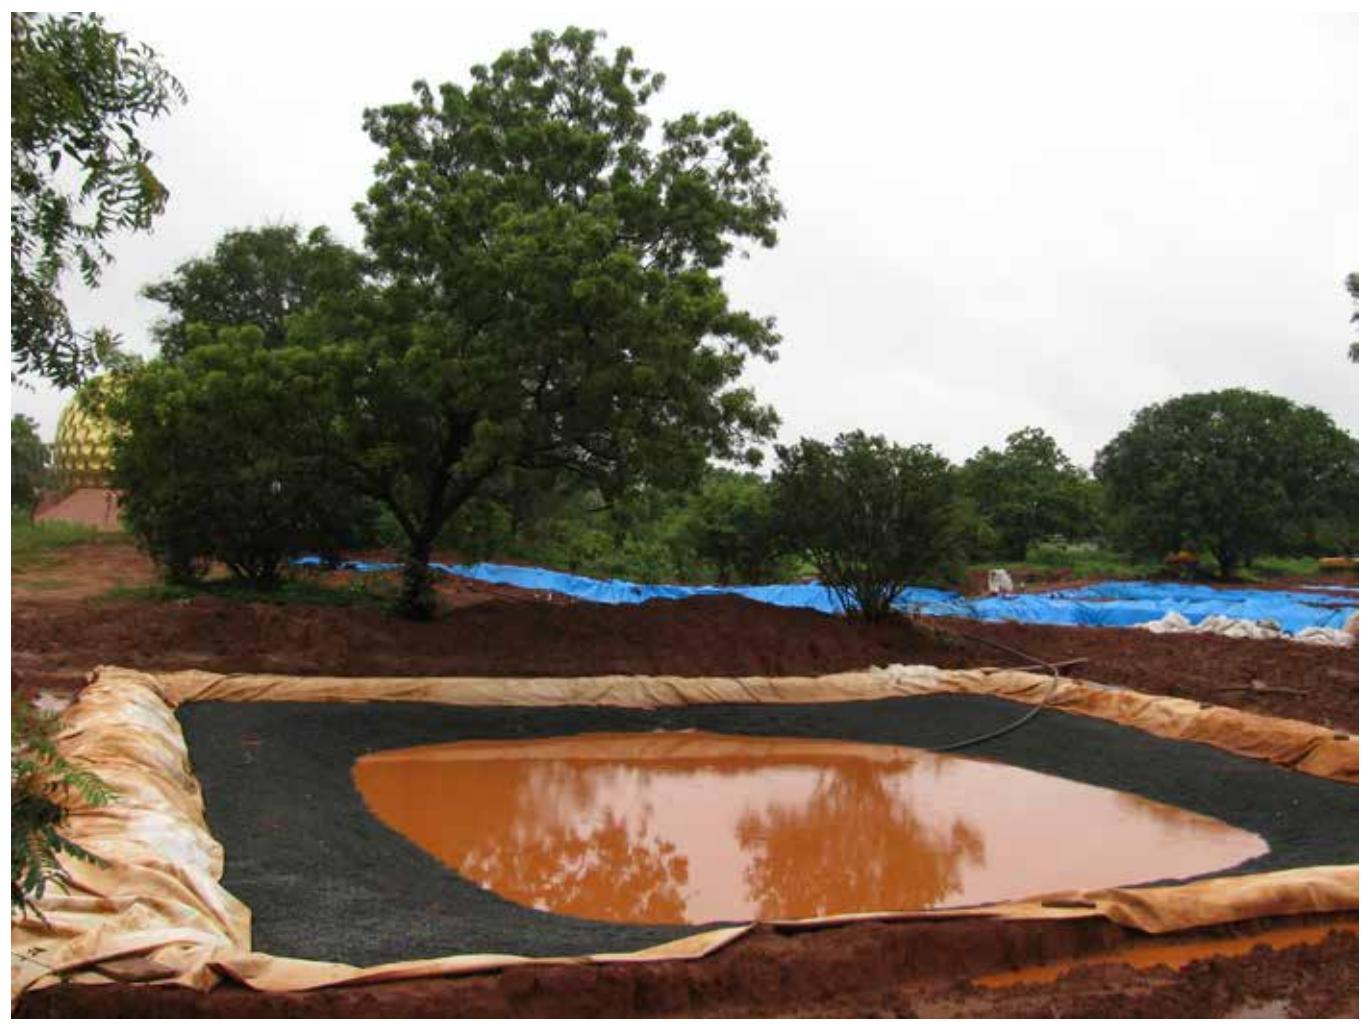
The mini test pond, 16 meters wide, fills under the monsoon rains.

And then, the Divine Humor took over: just one hour later, at 6: 30 am, the heavens opened up and the Auroville area was gifted with a tremendous down pour of rain,- the first of the winter monsoon season! Thus, this first of the test pond was immediately given its first trial as a water holding body.

When we arrived in the morning to see what had happened we were greeted with the sight of the pond about one quarter full of water already. Unfortunately it was muddy red water, because one of the outer protective bunds around the rim of the pond had broken under the force of the rain, allowing red muddy water to rush in....But it was proved to be a waterproof pond none the less!....A promising beginning to this series of tests aimed at selecting the best way to seal and waterproof the future Lake of Matrimandir.
